# Portland State University Lincoln Hall

## FEMA-178 Seismic Evaluation

RE: FEMA-178 Seismic Evaluation  
Lincoln Hall - Portland State University

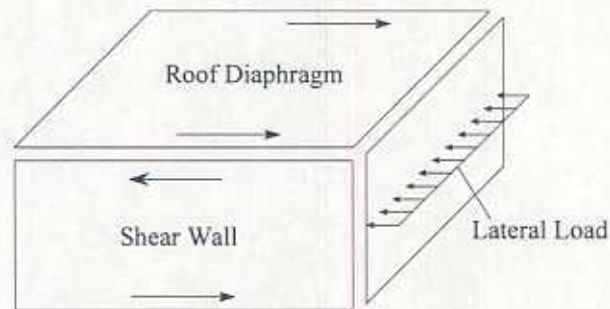
Loads such as wind and earthquake are typically considered to act on a building in a lateral (horizontal) direction, hence the name lateral load. To understand how loads are transferred through the building in a simplified case, consider the one story illustration shown below. A lateral load is applied perpendicular to a wall. The wall (concrete and unreinforced masonry walls at Lincoln Hall) then spans, much like a beam, between the foundation and roof (or floor in a multi-story building). As a result, a portion of the load is then transferred into the roof. The roof (called a diaphragm), spanning between the walls on each side, in turn transfers the load in the form of shear. The shear load is then transferred through the walls down to the foundation and into to the ground, completing the lateral load path.

Although these load paths become more complex in larger and multi-story buildings, the basic underlying concepts still apply. A complete load path must be defined for any building. If a portion of this path is missing, the building has the potential to collapse. For instance, in the illustration above, if the lateral load resisting elements (shear walls) were removed, it is clear that the structure would be unstable and easily collapse. Try removing two sides of a cardboard box and then pushing on it. The same type of argument might also be made if the connection between the diaphragm and roof was missing or lacked adequate strength. Again, various degrees of instability would be introduced.

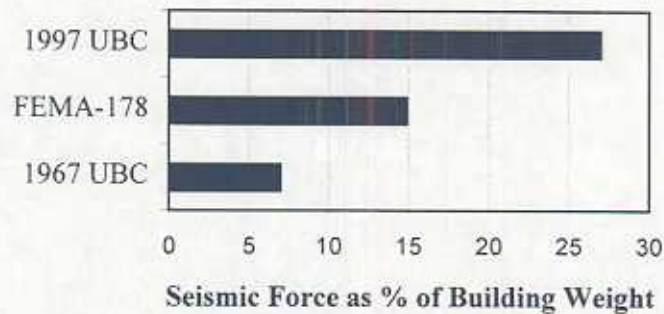
Calculations of lateral seismic forces are a function of a building's weight. In the intervening years since the original building's construction, the opinion and knowledge of seismic design has changed and improved significantly. Correspondingly, the code prescribed seismic design forces have increased substantially to reflect this new gained philosophy and knowledge. The following graph illustrates the changes in required seismic forces, as they relate to this structure expressed as a percentage of the building's weight. The change, for instance, between the 1967 (7%) and 1997 (27%) Uniform Building Code (UBC) seismic design force levels represent an increase of well over 300% as shown below.
